historic structure report  
architectural data section

# HOPEWELL VILLAGE

## THE IRONMASTER'S HOUSE

THE IRONMASTER'S HOUSE  
HOPEWELL VILLAGE NATIONAL HISTORIC SITE  
HOPEWELL, PENNSYLVANIA

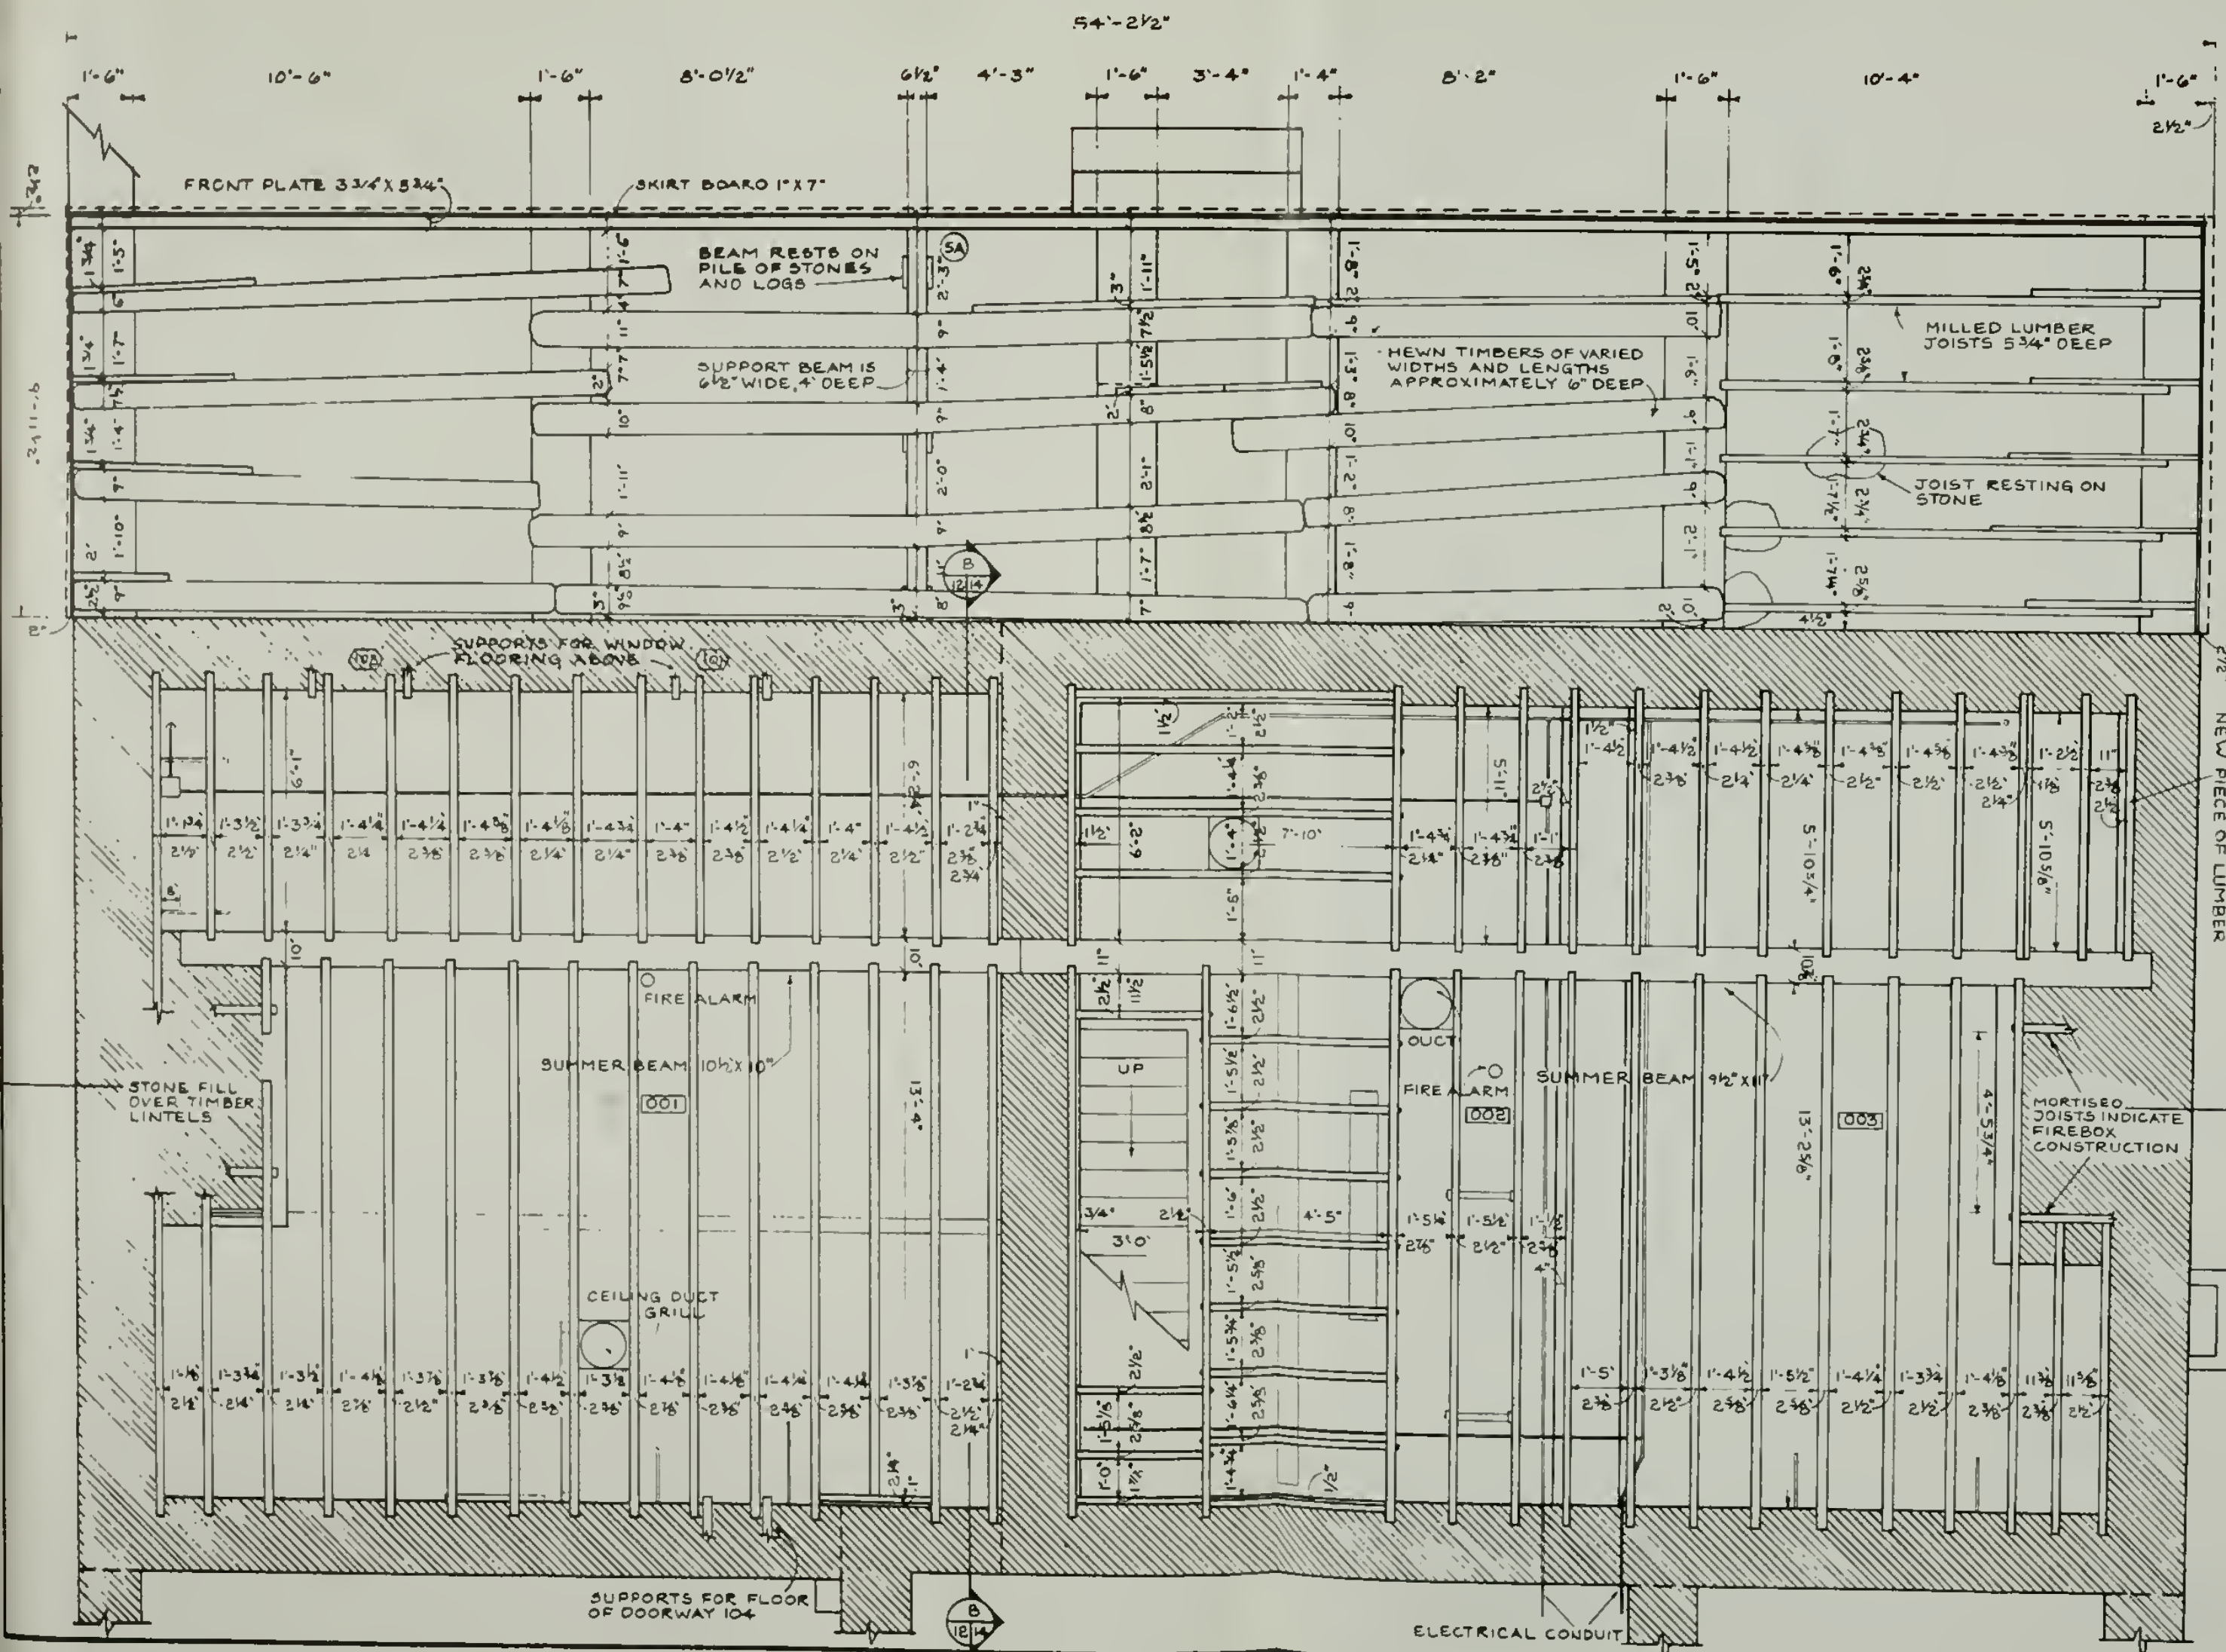
HEWN TIMBER SLEEPERS - OF VARIOUS WIDTHS, 5"-6" DEEP, SIGNS OF SURFACE ROT, IN PLACES NOT ADEQUATELY SUPPORTED BY STONES.

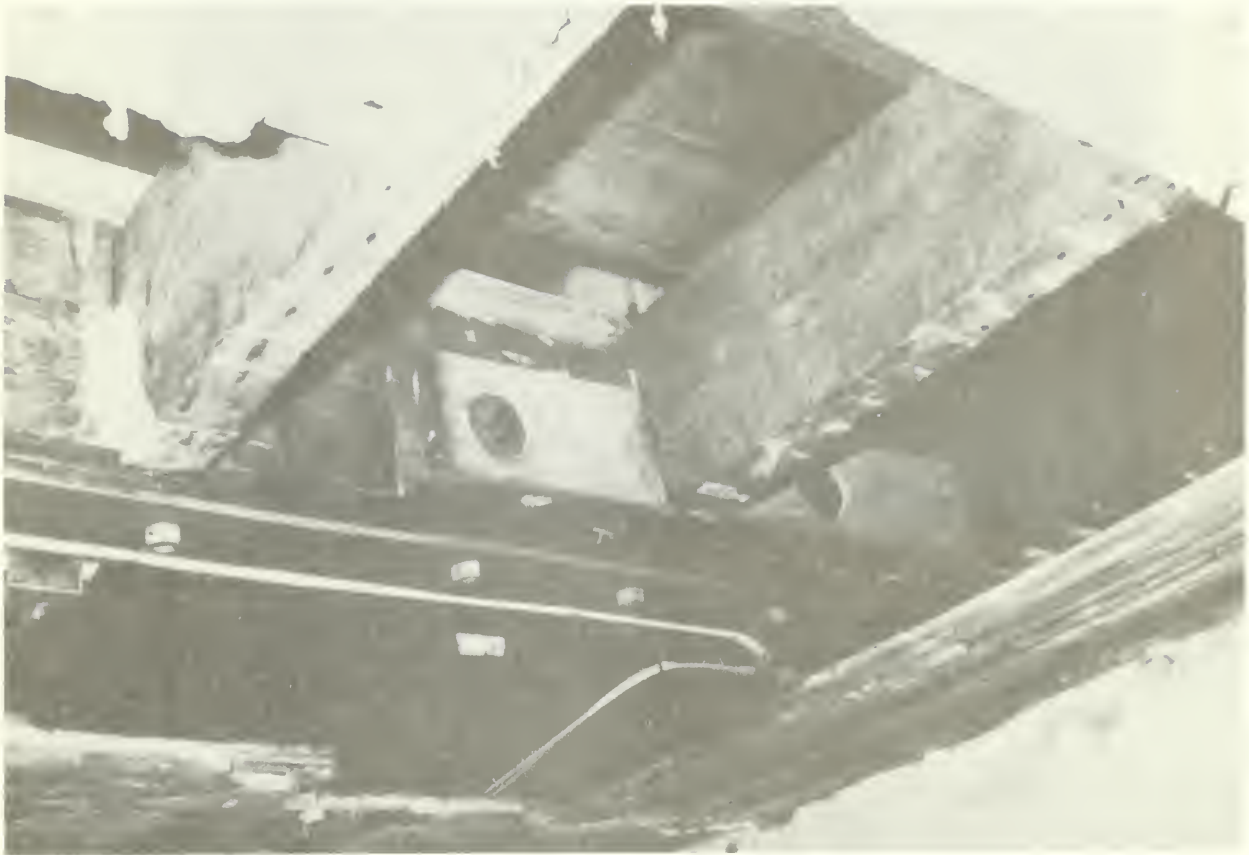
4. Room 004: moulder's dining room. Existing ceiling summer beam reinforced with new steel plates and new steel channels and existing joists reinforced with new hangers at east wall pocket. Pipe column removed, May 1980.

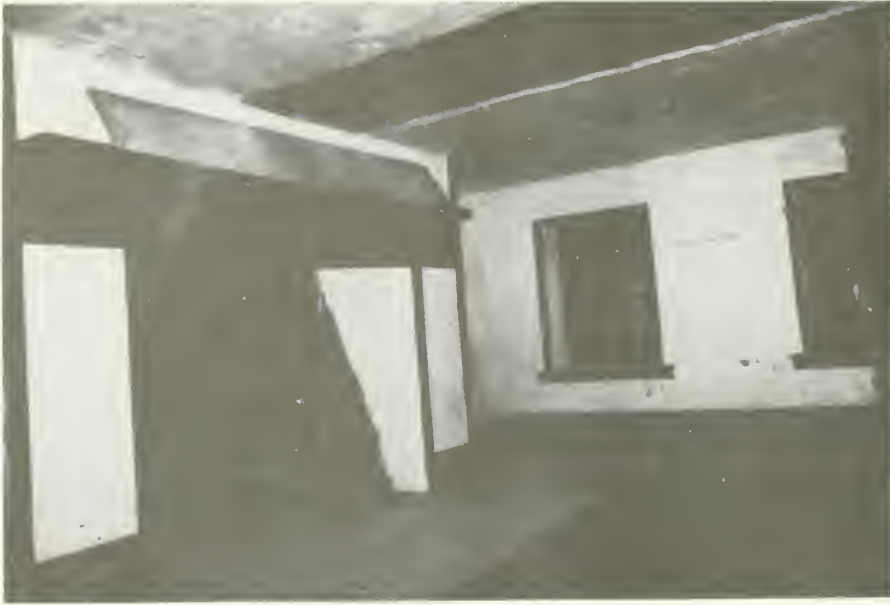
5. Room 005: moulder's kitchen. Existing ceiling summer beam exposed; flooring removed. View towards west side fireplace and hearth, December 13 1979.

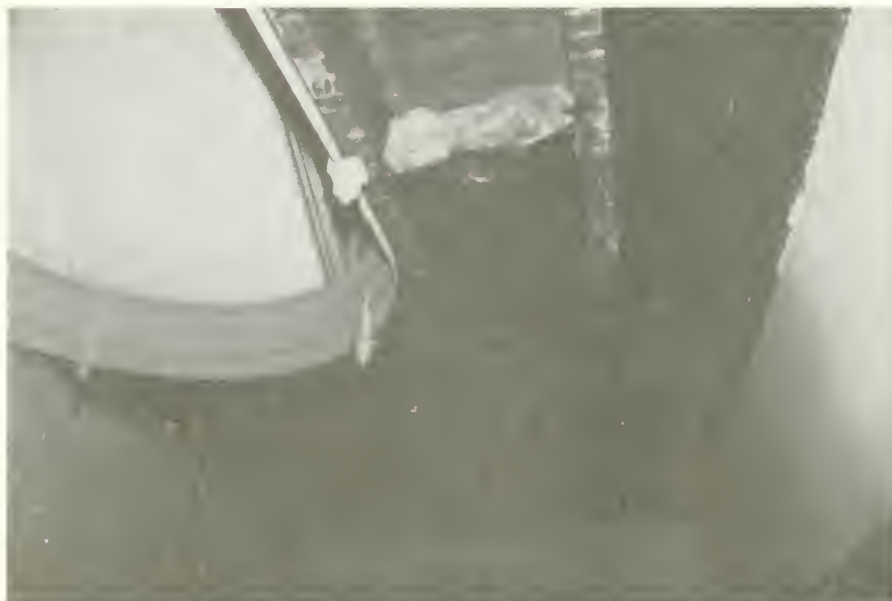
10. Room 102: central hall. View of existing ceiling summer beam and framing and stairwell trim. View towards front Doorway 101, December 13, 1979.

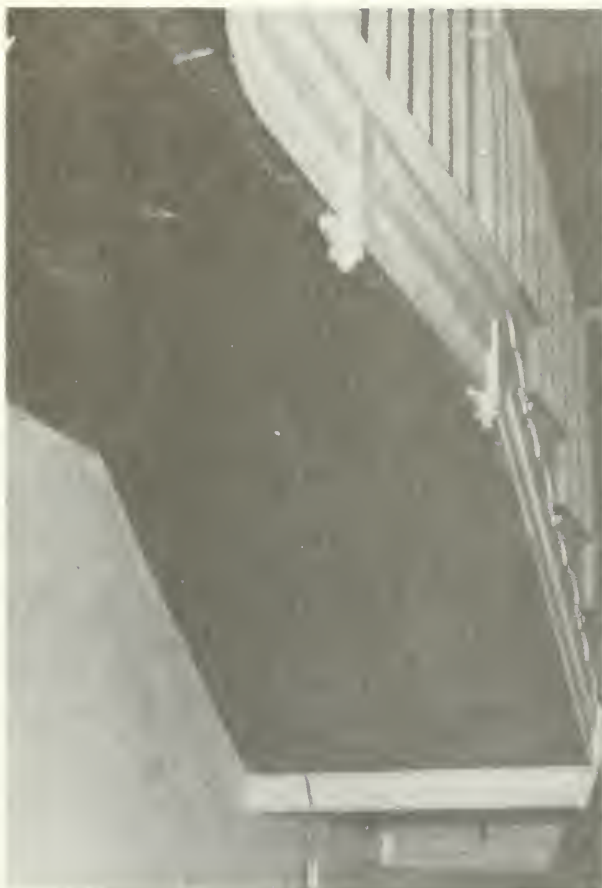
11. Room 102: central hall.  
Existing stair carriage  
exposed over Doorway 106,  
December 13, 1979.

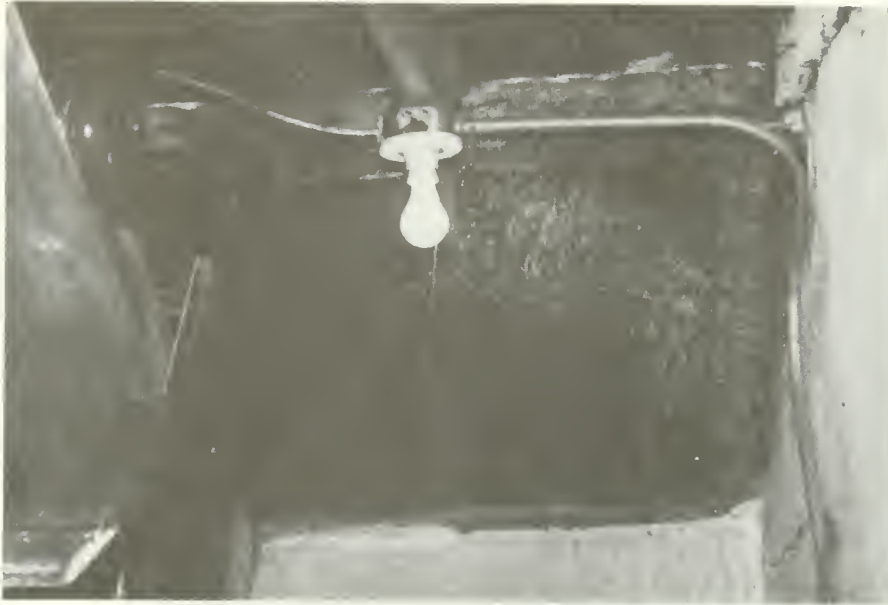
13. Room 102: stair landing framing in ceiling of enclosed stairs leading from Door 105 down into basement Room 002, December 13, 1979.

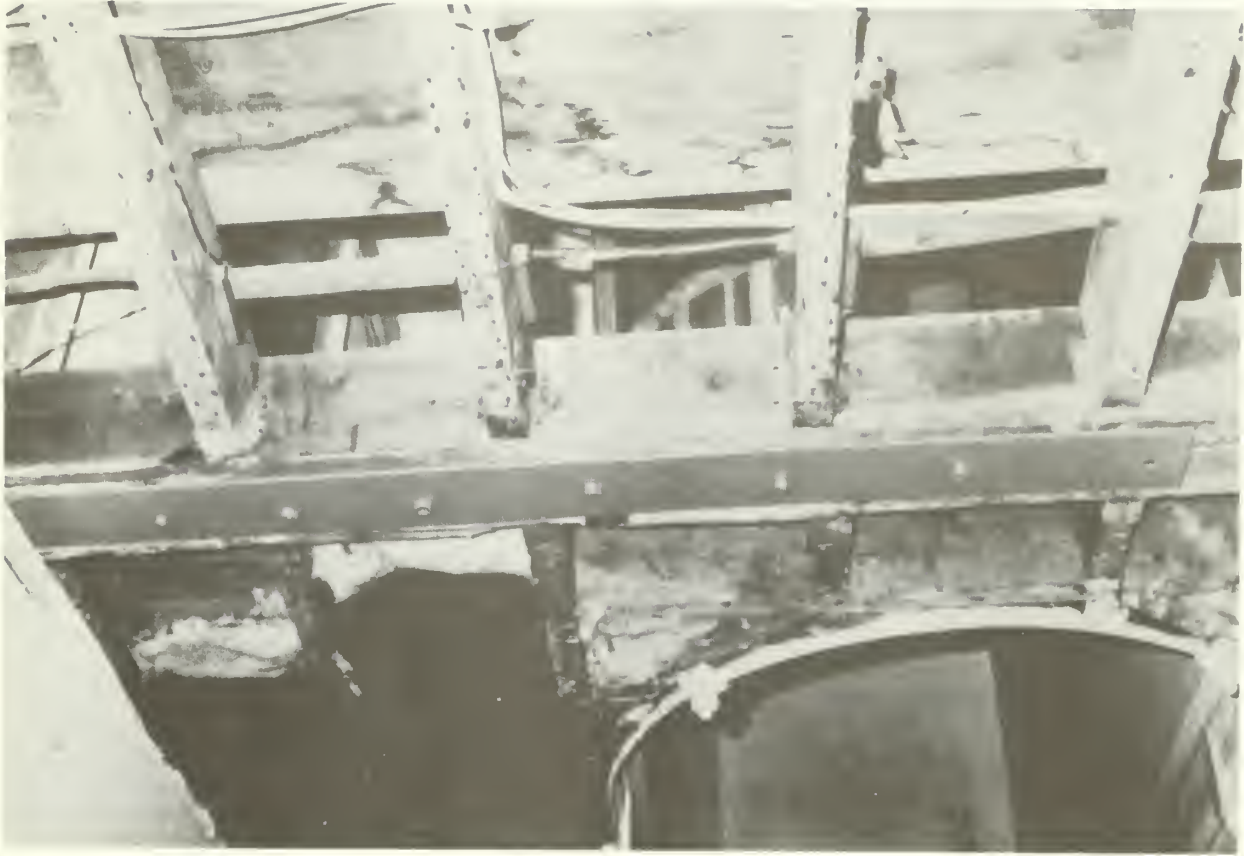
15. Room 102: central hall. Existing ceiling summer beam reinforced with new steel plates and existing joists reinforced with new hangers, May 1980.

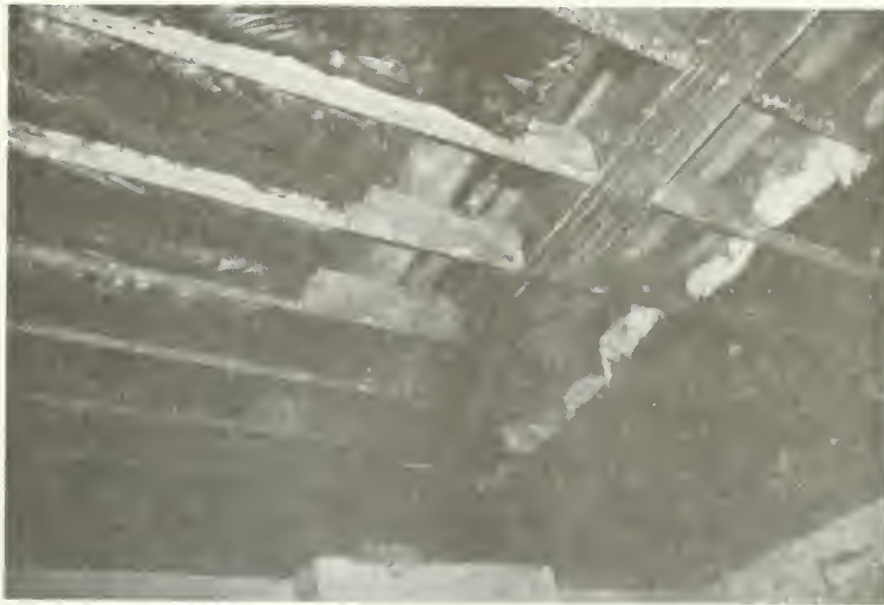
16. Room 103: northwest parlor. Existing ceiling summer beam, josts, and insulation exposed. View towards north wall and chimney, December 13, 1979.

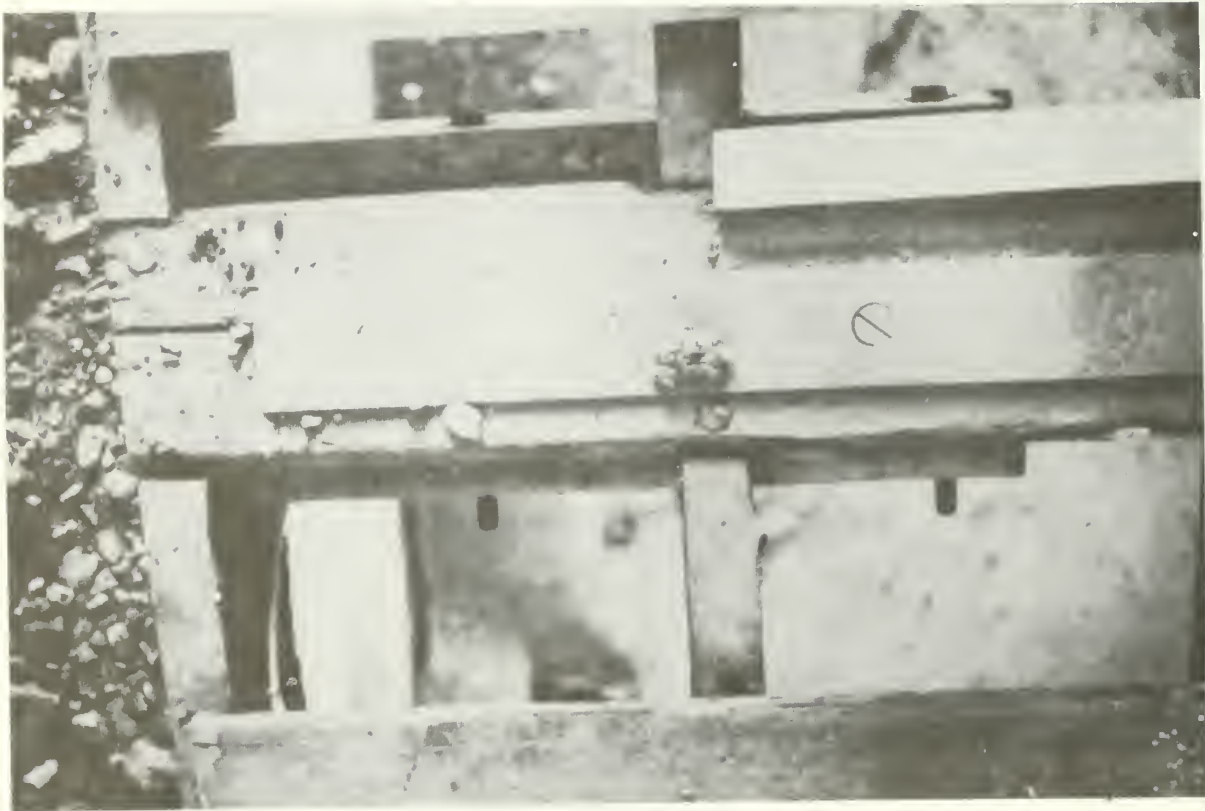
22. Room 104: east wing dining room. Top view of existing floor summer beam reinforced with new steel plates (top and bottom) and new steel channels extending into the stone fireplace pocket on the east wall, April 1980 (refer to photograph 4).

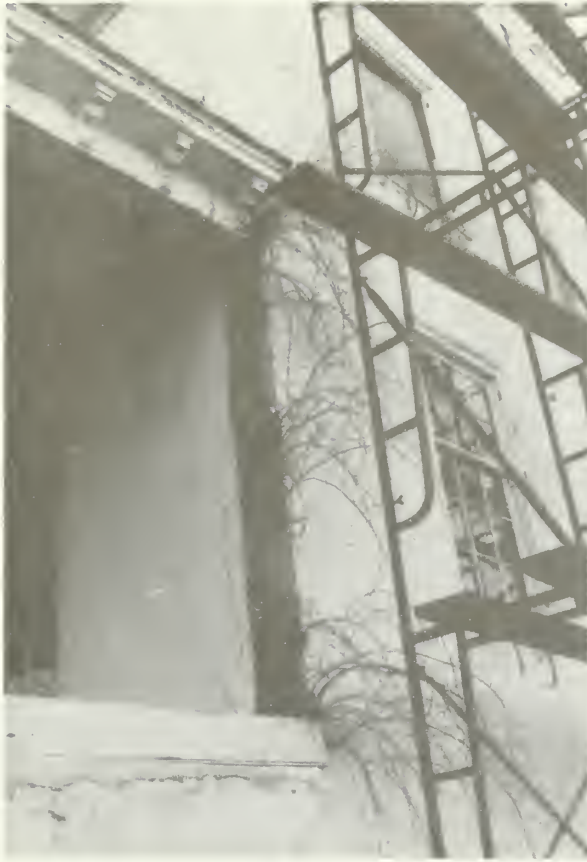
43. Front porch. Southwest corner pilaster removed to expose existing Washington Bower Vine, cause for wood rot in porch box beam, April 1980.

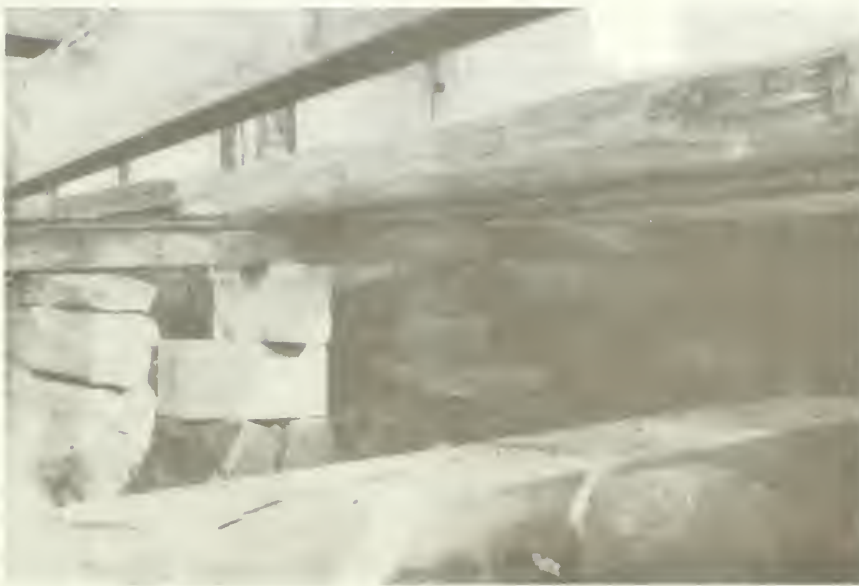
44. Front porch. Existing historic cribbing and stone pier next to new concrete foundation for new concrete masonry unit foundation wall, for support under column 4, April 1980.

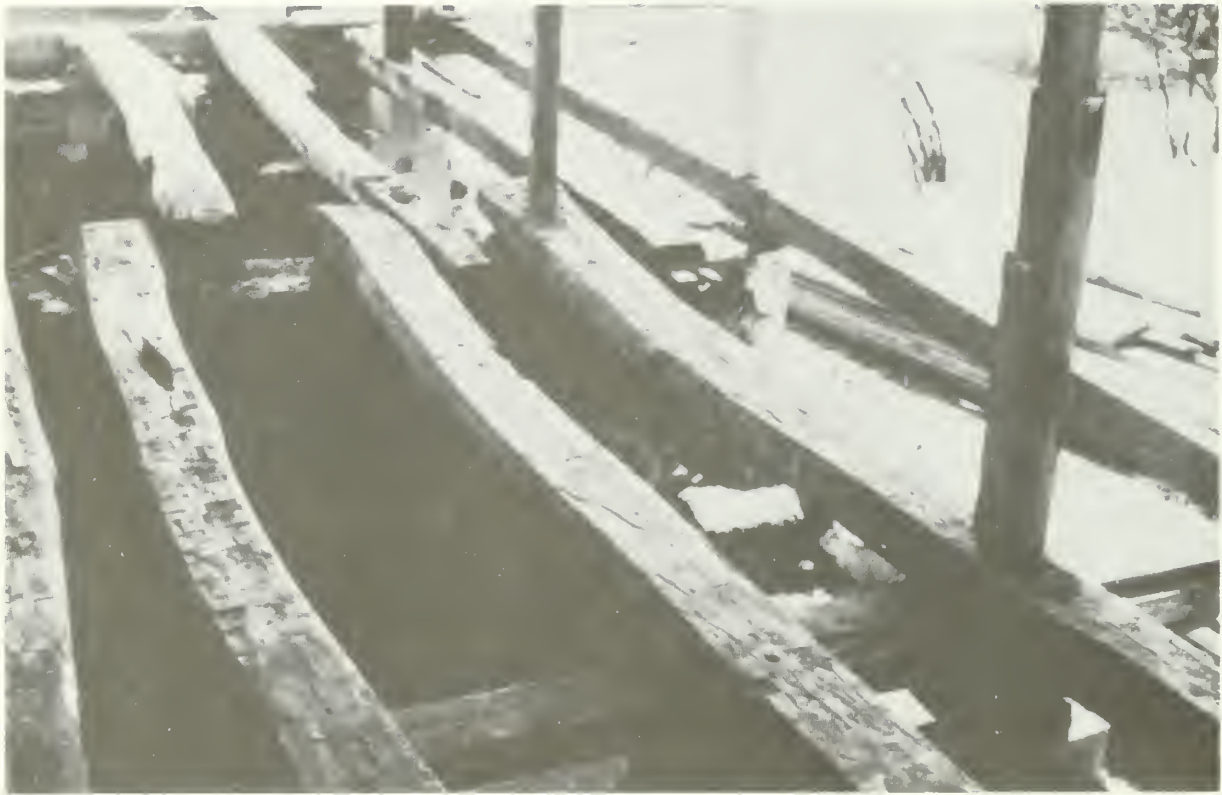
45. Front porch. Existing timber floor framing, dating possibly from the porch extensions of 1868-70; exposed for cleaning, brush preservative treatment, and additional framing reinforcement. View south over foundation walls 4, 5, and 6, March 15, 1980.

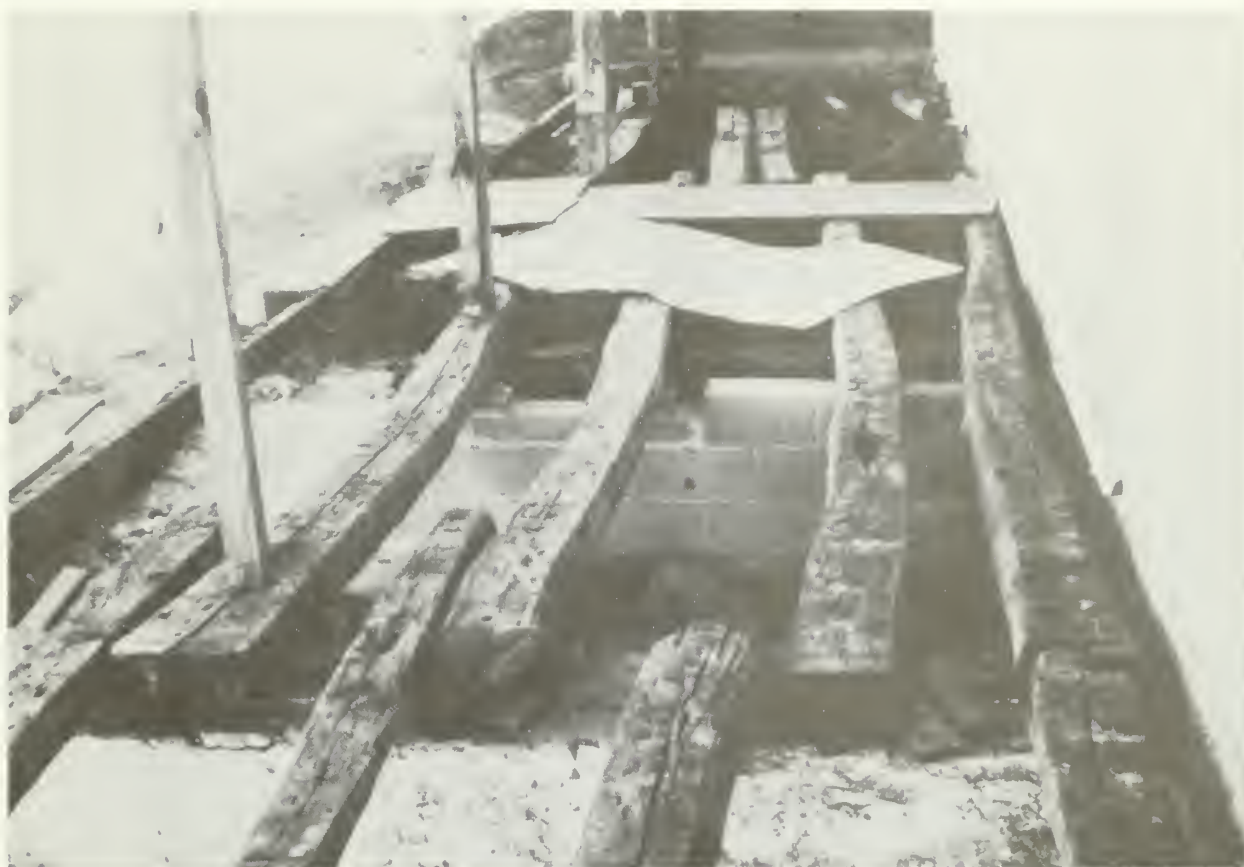
46. Front porch. Existing timber floor framing, exposed for treatment and additional framing reinforcement. View north along foundation walls 5, 4, 3, 2, and 1. New concrete masonry unit foundation wall to support column 4, April 1980.

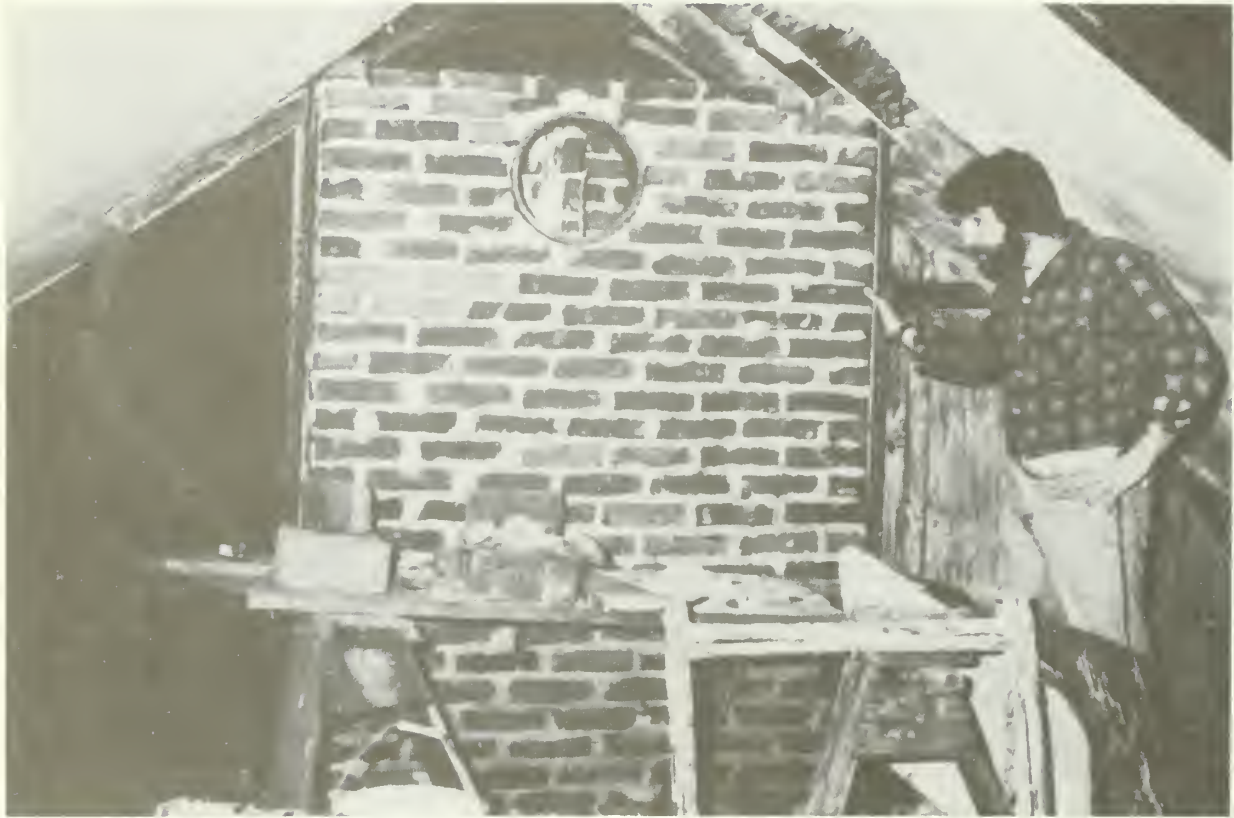
47. Room 304: east wing attic. Reconstruction of the east wing chimney from base at attic floor up through roof. Mason Stephen Reisinger standing next to his work, May 1980.

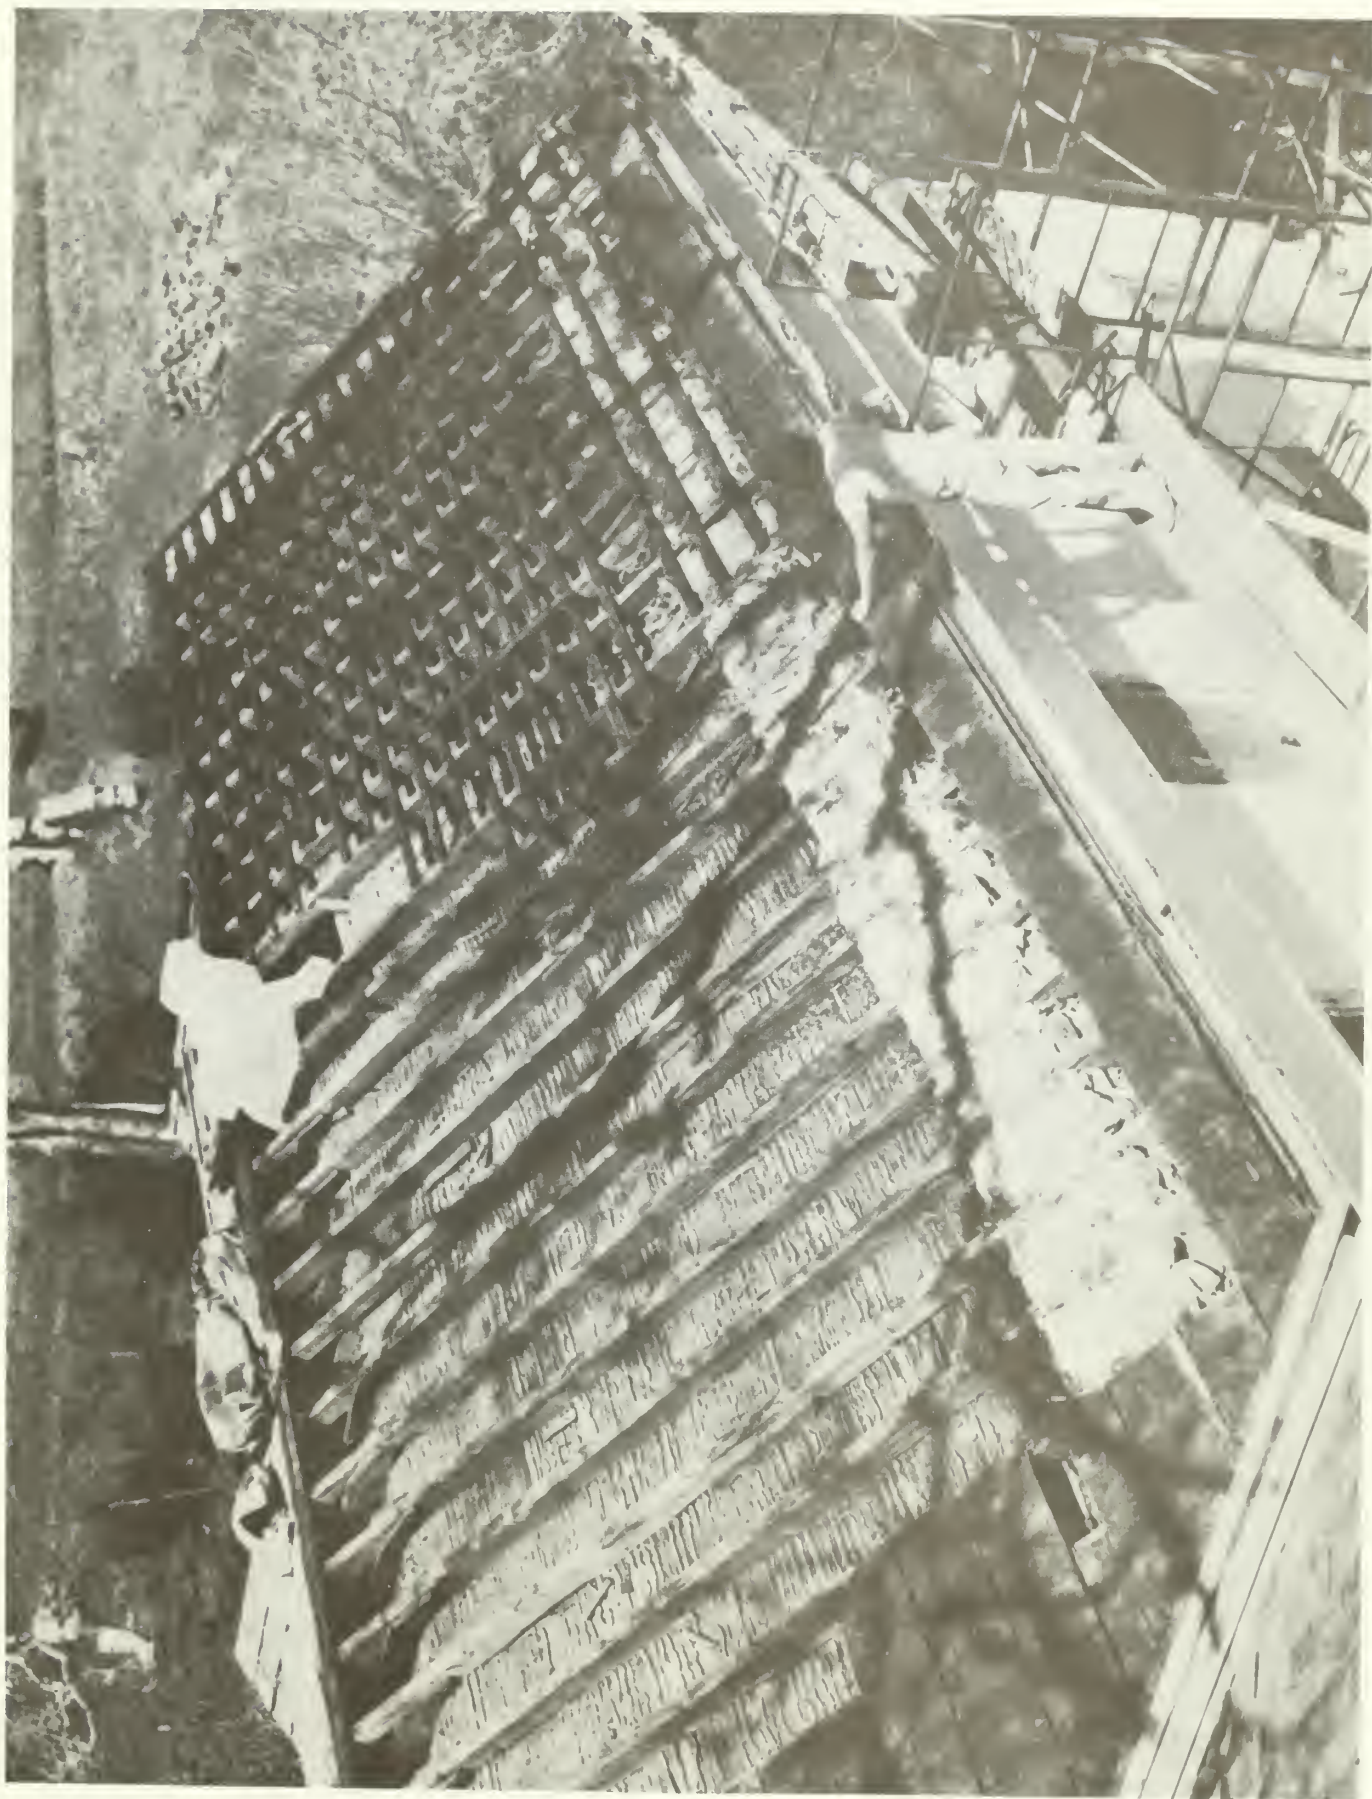
48. East wing roof. South slope exposed, showing existing rafters, collar beams, shingle lath (nailers), lath and plaster, starter board, and gutter. Contractor's field supervisor Stephen Reisinger inspecting existing conditions before restoration work. April 1980

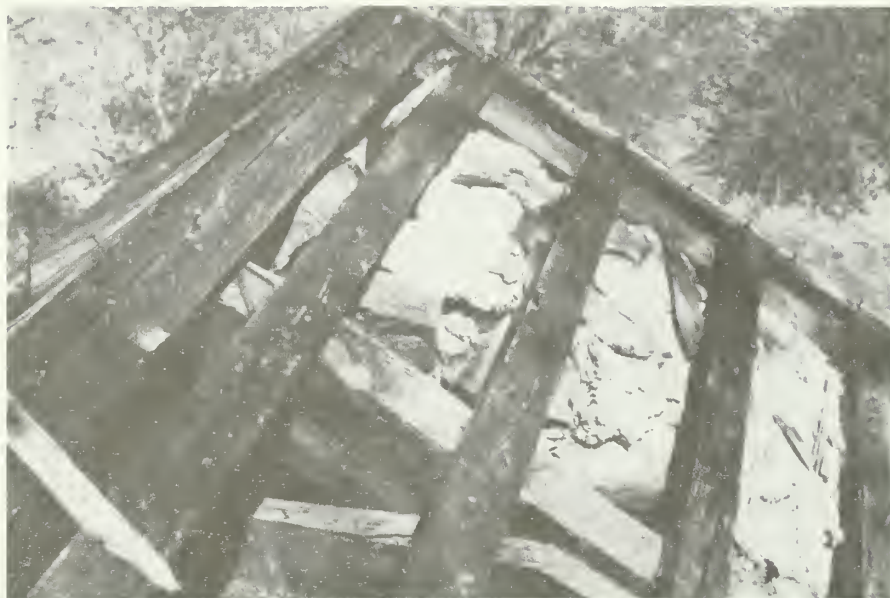
49. East wing roof. Existing rafter collar beam and nailers at east gable and along ridge, April 1980.

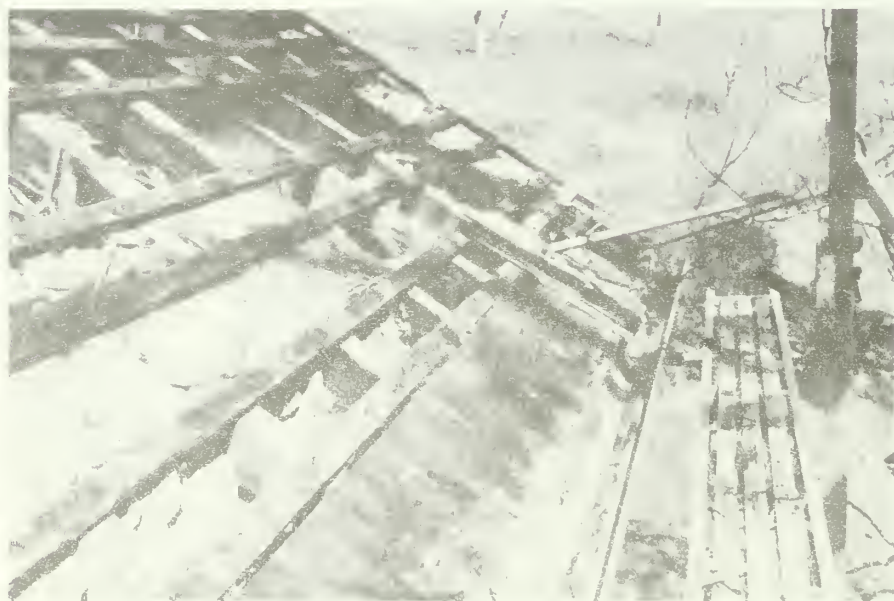
50. East wing roof. Existing rafters, nailers, and starter board at eaves of south slope, April 1980.
